JHRP-13-75

WRONG-WAY MOVEMENTS ON DIVIDED HIGHWAYS

Technical Paper

Purdue University
West Lafayette, Indiana
July 30, 1975

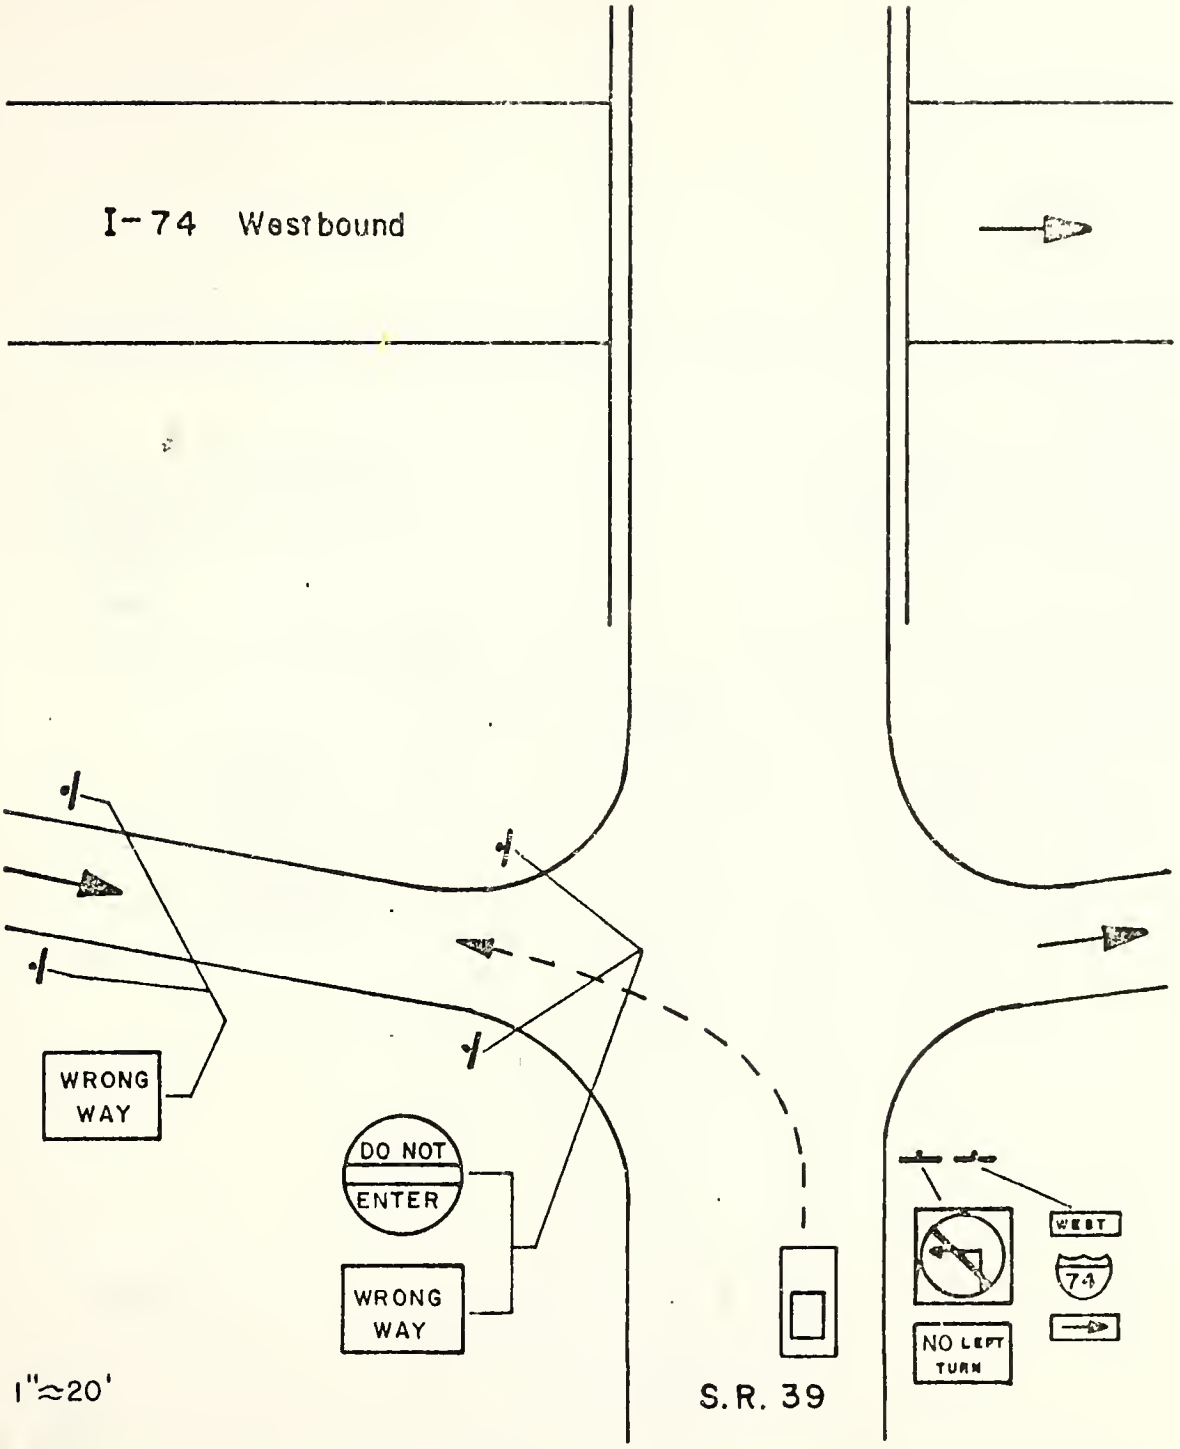
FIGURE 6. The Interchange of I-74 and State Road 39 - A Typical Diamond Interchange Where a Wrong-Way Movement Occurred

Figure 6 illustrates a typical wrong-way access point of this category. It is in a diamond interchange providing access to I-74 from S.R. 39. The crossroad is two-lane, undivided and the exit ramp has wrong-way signing. Area land-use is light. The driver who made the wrong-way movement here was very old and apparently became confused as he asked a gas station attendant for directions three times. While it was not possible to assign a certain cause to this wrong-way movement, the drivers reduced ability was probably a major factor.

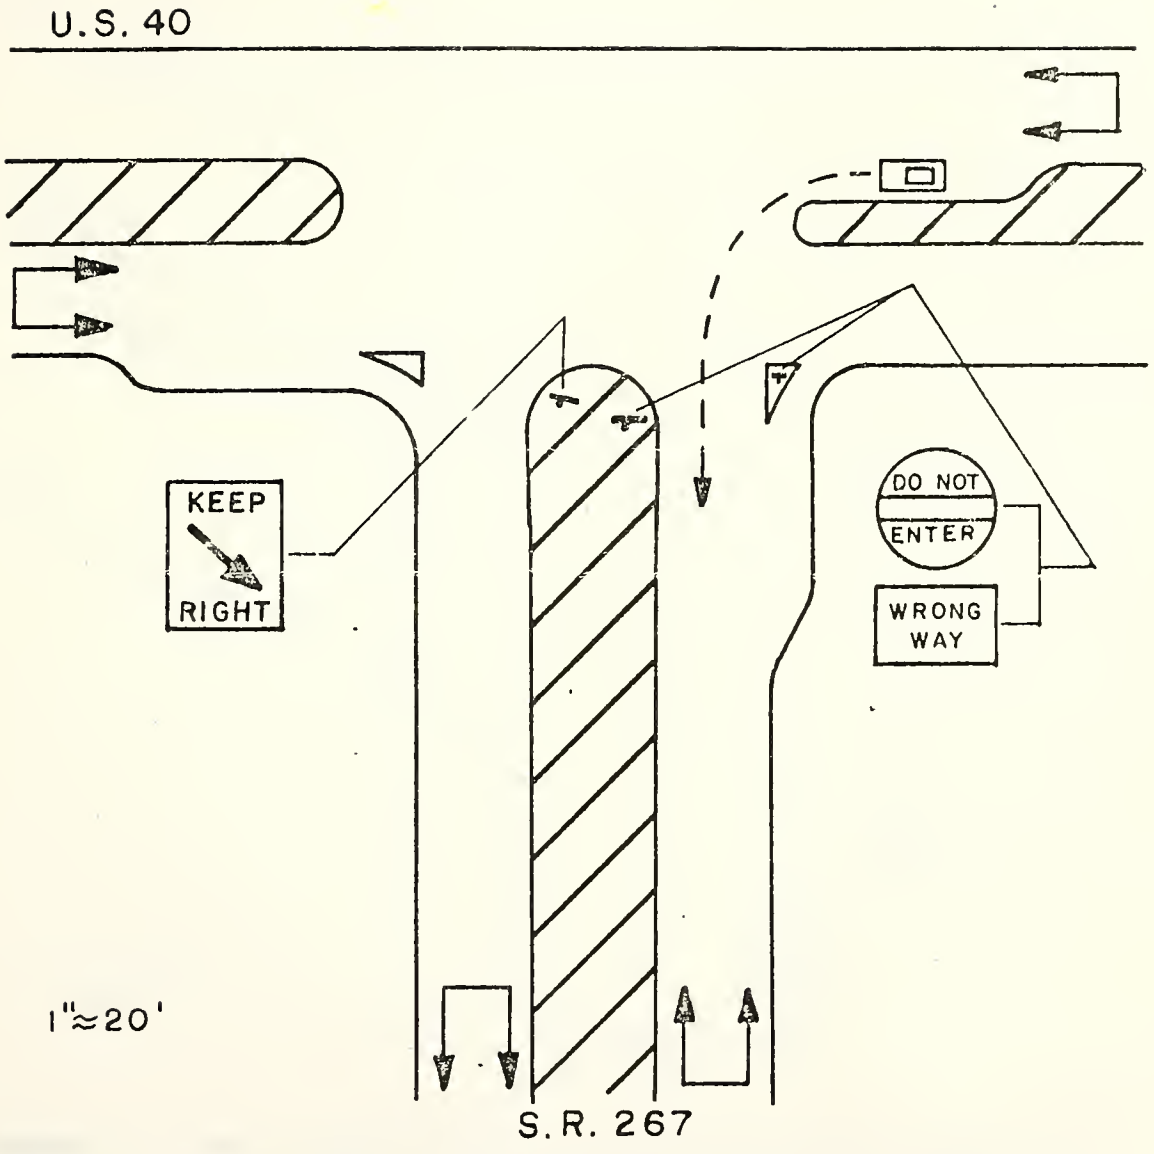
FIGURE 7. The Intersection of U.S. 40 and S.R. 267 - A Major Intersection Where a Wrong-Way Movement Occurred

In Figure 7, the intersection of U.S. 40 and S.R. 267, one of the major intersection category where a wrong-way movement began, is shown. Although the intersection's signing is good, the width of the median does not permit the approaching driver to visualize the total intersection where vehicles on U.S. 40 must traverse a wide unchannelized space to make a left turn correctly. The accident which originated here occurred at night and the lighting was poor. Some commercial development exists on U.S. 40 east of the intersection. The driver of the wrong-way vehicle was drunk.

This wrong-way movement was probably caused by a combination of poor lighting, the drivers condition,and the geometric layout of the intersection.

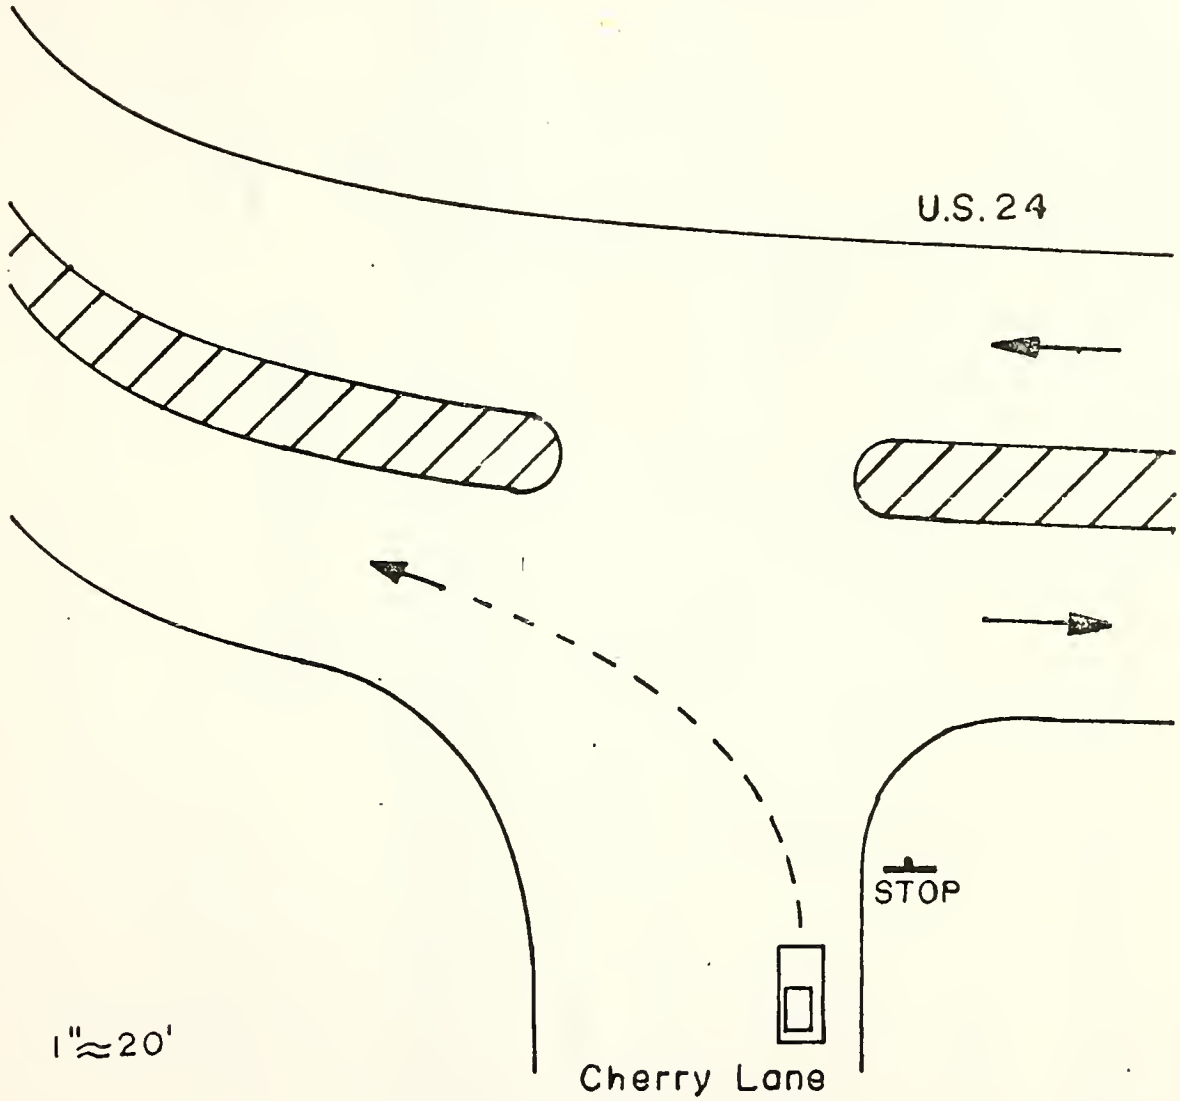
FIGURE 8. The Intersection of U.S. 24 and Cherry Lane - A Typical Minor Intersection Where Wrong-Way Movement Occurred

The intersection of U.S. 24 and Cherry Lane, near Fort Wayne (Figure 8) is a minor intersection providing access from a residential area to U.S. 24. Although overall intersection visualization is very good, the intersection lacks any type of directional signing. The accident here occurred on a dark, rainy night with very low visibility. With no directional signing, the driver apparently became confused and made a left turn into the wrong lanes.

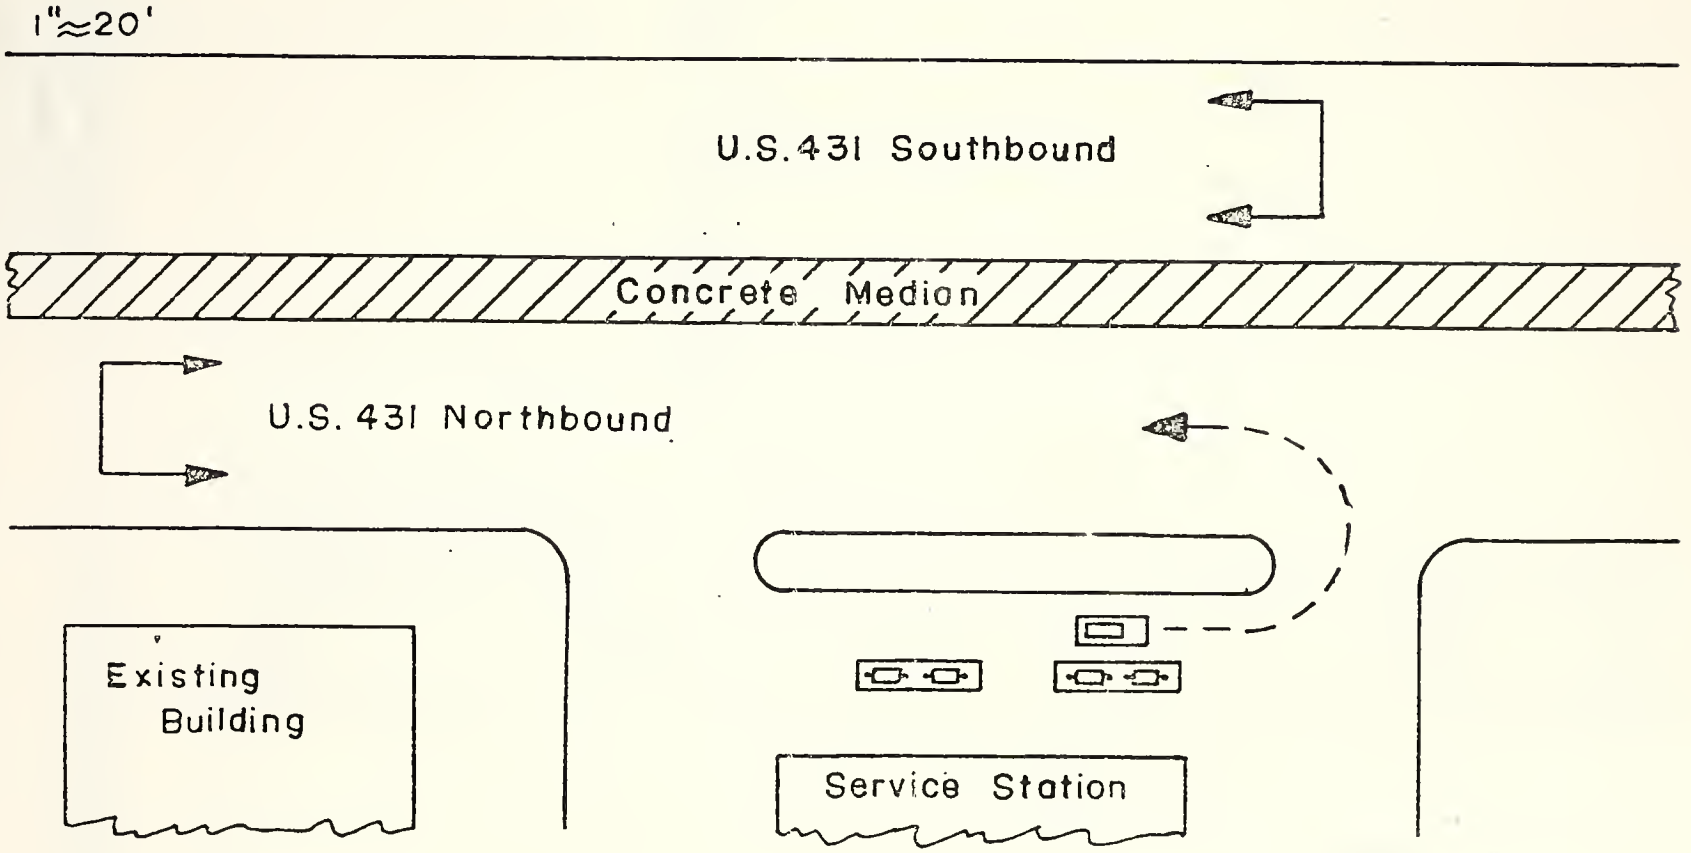
FIGURE 9. Driveway on U.S. 431 - Typical Driveway Where a Wrong-Way Movement Occurred

A typical wrong-way movement originating from a driveway is shown in Figure 9. There was no directional signing and it is likely that a directional, channelized driveway exit could have prevented the wrong-way movement which began here.

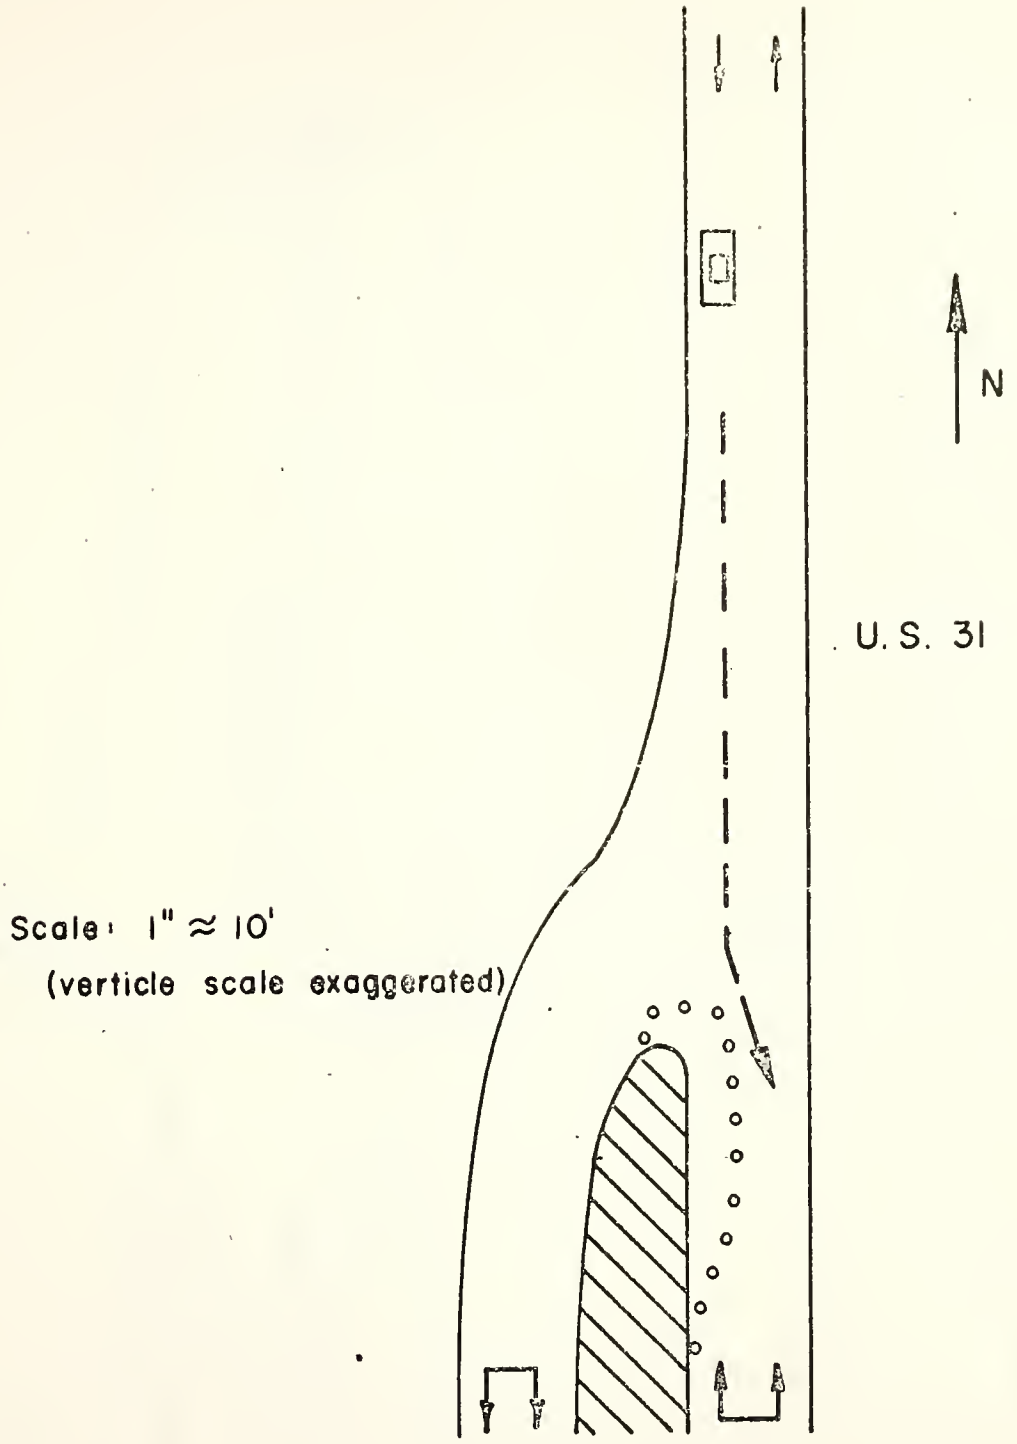
FIGURE 10. Transition on U.S. 31 - Site of Seven Wrong-Way Accidents

Seven accidents occurred at the transition on U.S. 31 north of Kokomo (Figure 10). This transition, used before all of U.S. 31 was improved to a divided, four-lane highway had a configuration conducive to wrong-way movements. Vehicles approaching the four-lane section had to bear right to avoid driving into the wrong lanes of the divided highway. Most of the accidents also happened at night. Generally, the configuration of this transition and the inability of the driver to see the overall transition area were responsible for its wrong-way movement problem.

Transitions from an undivided to a divided highway are a relatively frequent source of wrong-way movements, as well as other operational problems. Figure 16 illustrates the two basic transition configurations. Configuration A is very poor design and should never be used as it requires drivers to read and understand signing instructing them to bear right to enter the transition in the right direction. This is not in accordance with the principles developed earlier, namely, that wrong-way movement prevention systems should not depend on signing. Configuration B is much better practice and should always be used.
